The Eastlake Community Church Story

Long Version Photo Essay

Entry: #RESI34E128 Category: House of Worship Contractor: Sound Image

Sound Image Escondido, CA

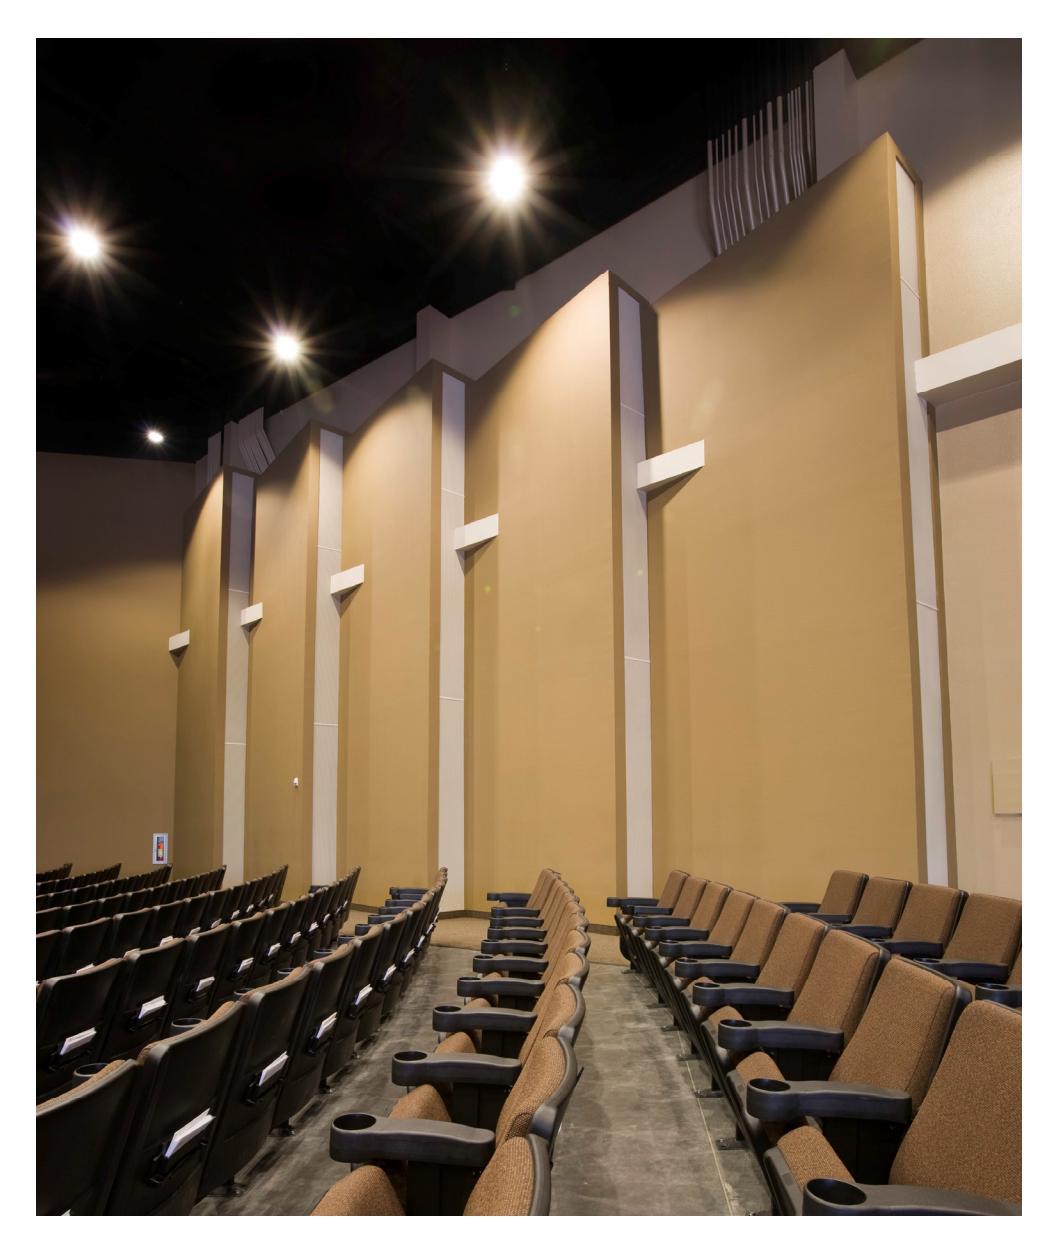
The house-right Z-wall treatment is mirrored on the house-lift side of the room. This added geometry eliminates most of the acoustical problems that come with parallel side-walls, and creates sound absorbing traps inside the cavities that are behind the 18"-wide, perf-metal, vertical faces. The treatment also adds character to the room.

Normally, the walls of a pre-engineered building would be hard, flat and parallel. Obviously, this is not good for a live sound venue. The solution: the side walls were constructed in two layers. The structural walls were built to meet code requirements, using standard methods and materials. The Z-shaped, inner layer of the side walls were designed to not only minimize side-to-side flutter echo, but also to act as passive, broadband sound traps.

The Z shape creates a hollow space between the structural and acoustical walls. The narrow vertical face is finished with heavy-gage perforated metal, which allows sound to collect inside the cavities. Inside the trap cavities, the wide vertical surfaces are lined with R-30 batt insulation.

The Z-walls are constructed from standard building materials and required no special construction trades nor techniques to fabricate. Other than the perf metal panels, the exposed surfaces of the side walls are painted, gypsum board over steel stud framing.

The side wall Z-traps are oriented to catch, as much as possible, the reflected energy coming off the glass back wall. Because the glass wall is one large set of sliding doors, no drapes nor other treatment was planned. The glass door system is 12' high and spans a width of 60'. No mid- nor high-frequency acoustical help here, however, the low-frequency absorption properties of the glass are helpful.

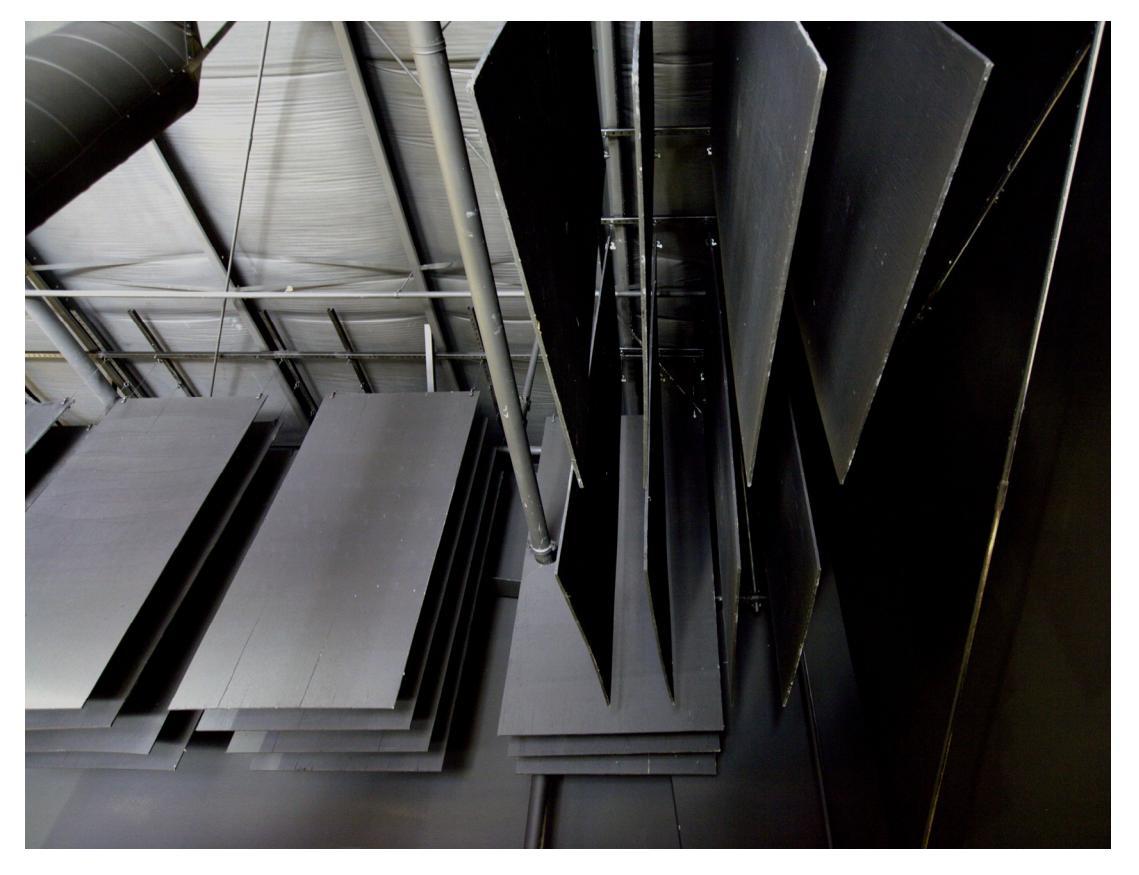
4' x 8' plywood panels are used to create active, limp-mass bass trapping. These panels free-hang from structural points located in the back corners of the sanctuary, above the two parent view rooms (cry rooms). More panels are installed near the ceiling, along the upstage wall.

Above the parent rooms, we had an opportunity to do some significant, active bass trapping. In each corner, 928 sq. ft. of limp-mass material was installed to contain the massive amount of residual, sub- and low-frequency energy that the system would produce. This is one of the most significant elements of the overall acoustic design. Without these baffles, the room would have suffered the fate of so many other contemporary music rooms; general boominess or muddiness due to lack of sufficient low-frequency absorption.

Similar active bass trapping was installed across the width of the upstage wall as well. For this project, the limp mass was a very common and inexpensive building material; ½", fire-treated, plywood.

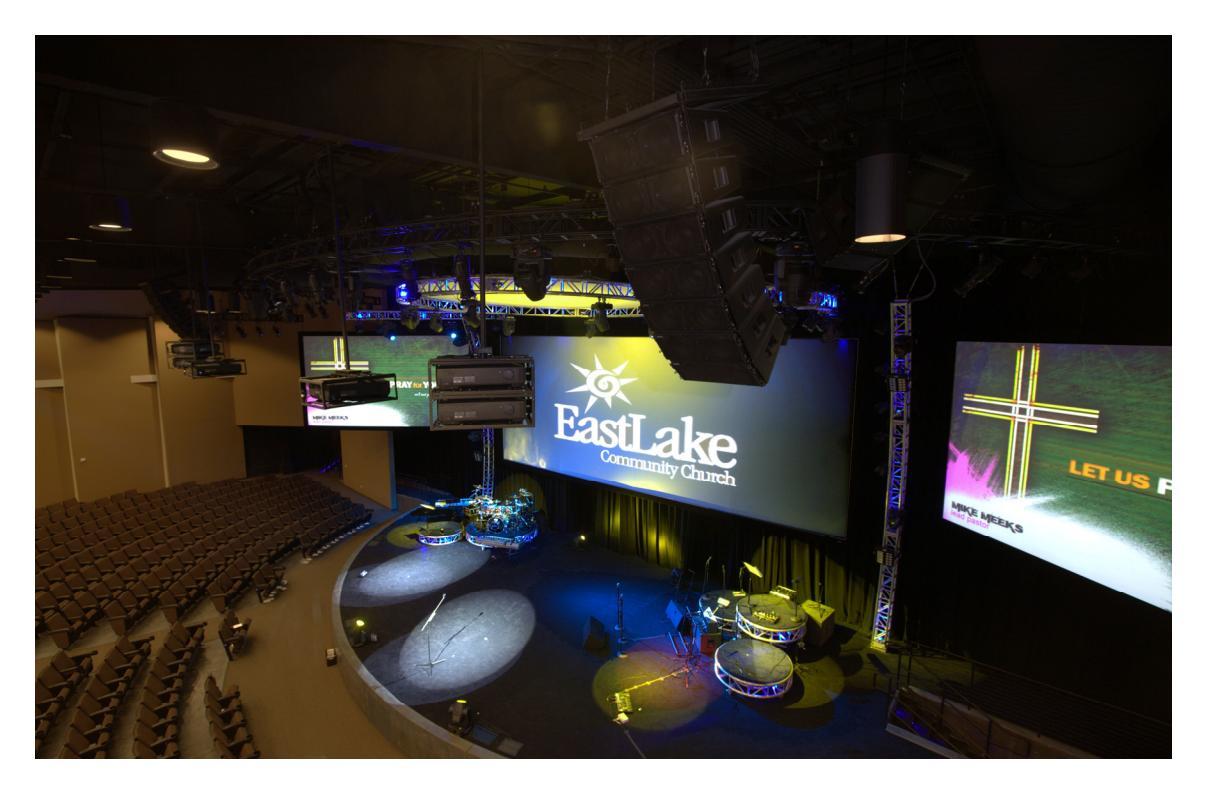
An overhead view of the stage.

The stage is quite large - a semi circle that is 60' wide by 33' deep. For mass and rigidity it was recommended that the stage be made of solid concrete. This was acceptable to all because it fit into the "industrial warehouse" look that the church liked. The stage is fully carpeted, with no other notable, structural features.

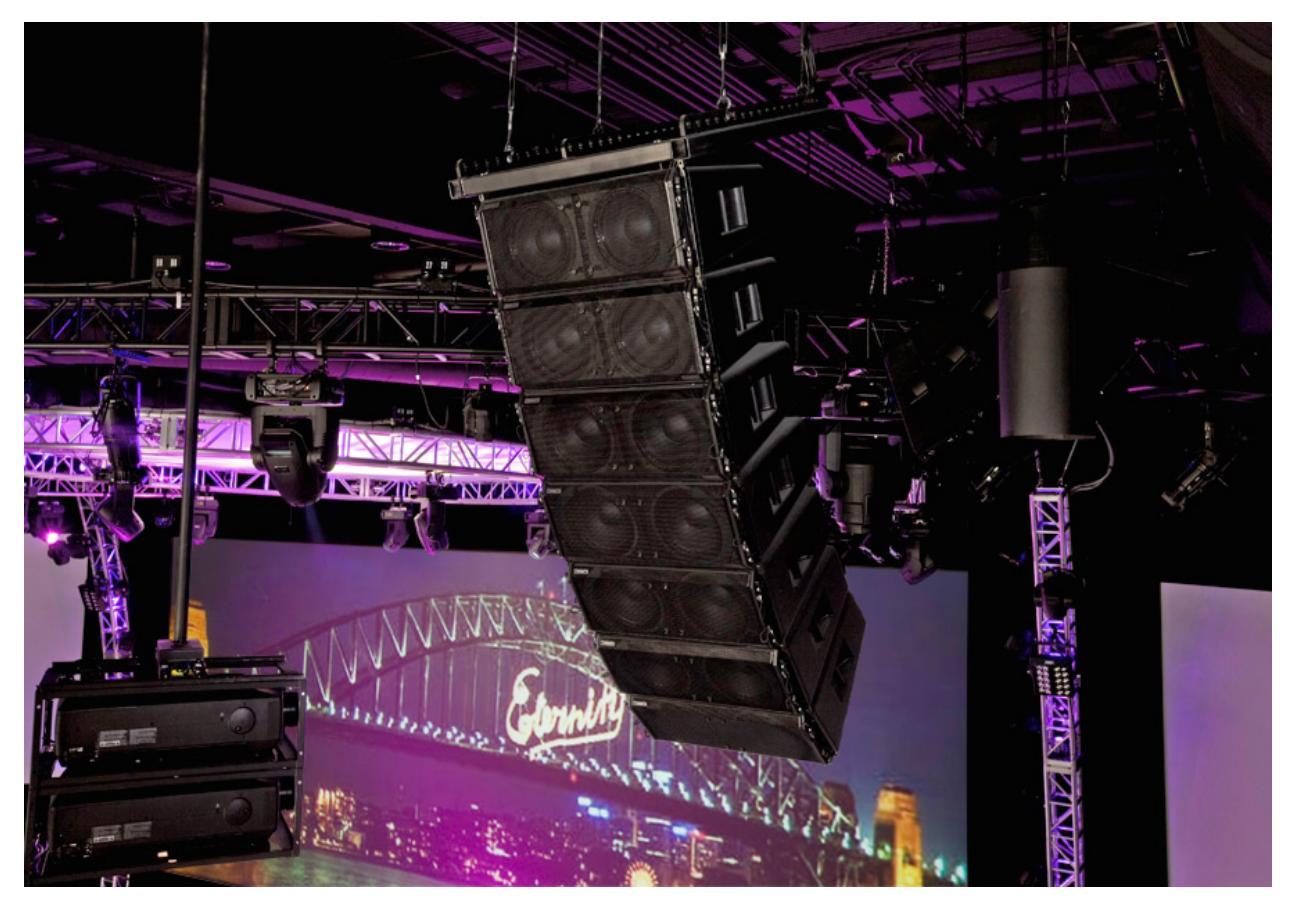
The house-right QSC Wideline array is highlighted along with two, stacked, Sanyo PLV-HD150 IMag projectors. The center graphics screen can be seen in background.

The Eastlake audio system was the driving element behind many of the design decisions that prevailed. The main loudspeaker package consists of a pair of QSC Wideline 10 line arrays, configured as a stereo pair. Each array has seven, dual 10" modules.

This package was key to addressing several of the most important design requirements. First was the need for a high-quality, high-powered, main loudspeaker package with an extremely wide horizontal coverage pattern - 140 degrees for the WL2102's.

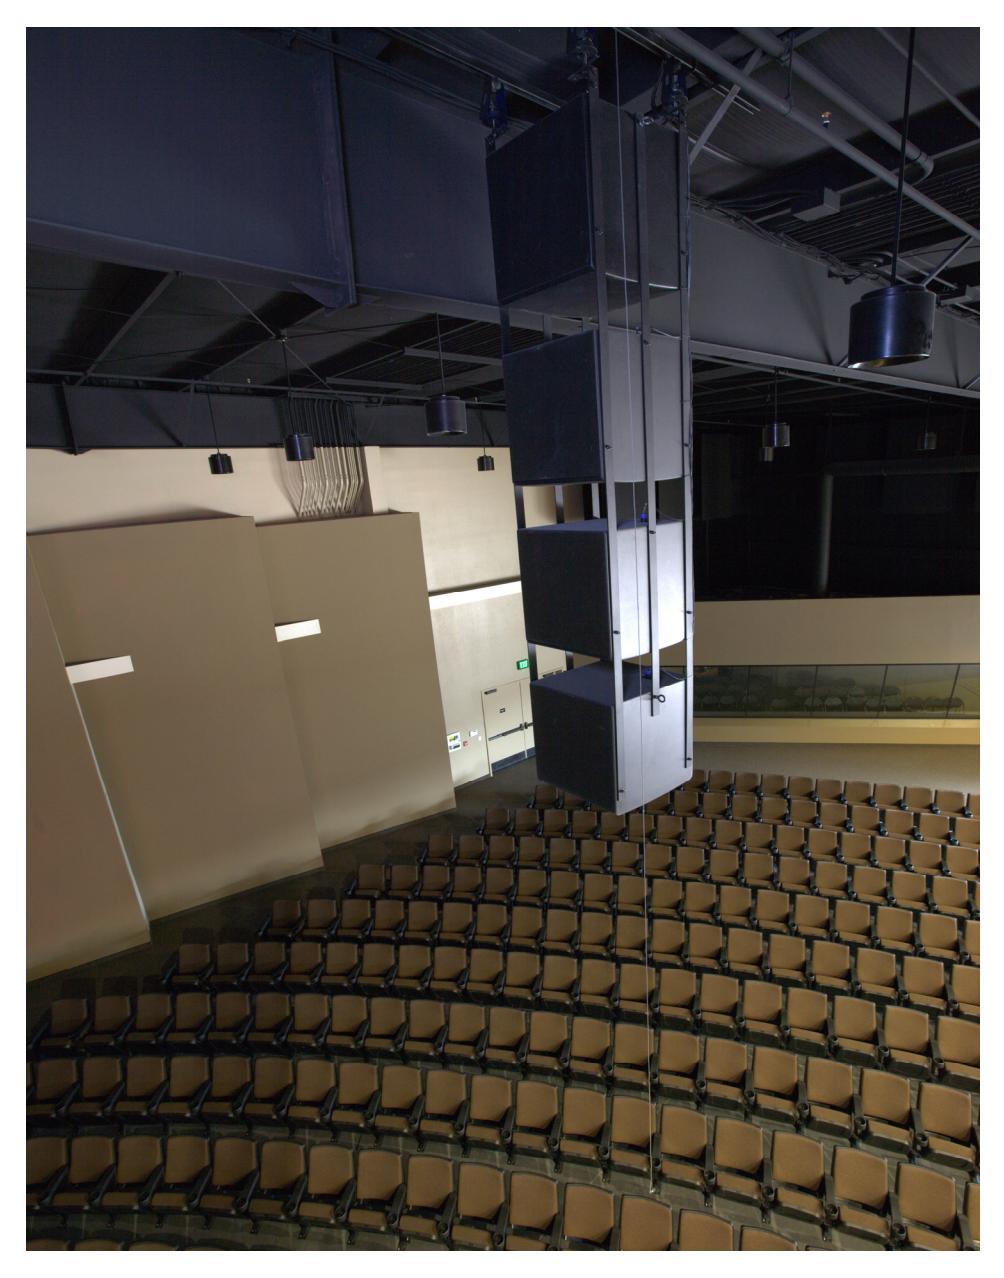
The vertical, end-firing, subwoofer array is possibly the most unique application of technology in the Eastlake system. This array is suspended above the house-right seating area. Two more arrays hang above the center and house-left seating areas.

The final design and installation include a combination of vertical, end-firing, cardioid sub arrays and stage-front subs. Each vertical array is isolated from the structure using Mason Industries' Spring Deflection Isolators. In total, the system has sixteen, Yamaha IS1118, single 18" sub cabinets.

Three vertical arrays are deployed over the main, fan-shaped seating area. The house left and right arrays consist of four cabinets each. The center array, located above and slightly forward of the FOH mix position, has only three boxes. In total, eleven, single 18's were flown. Five bunkers were built into the front arc of the semi-circular, concrete stage. A single, 18" cabinet is installed in each.

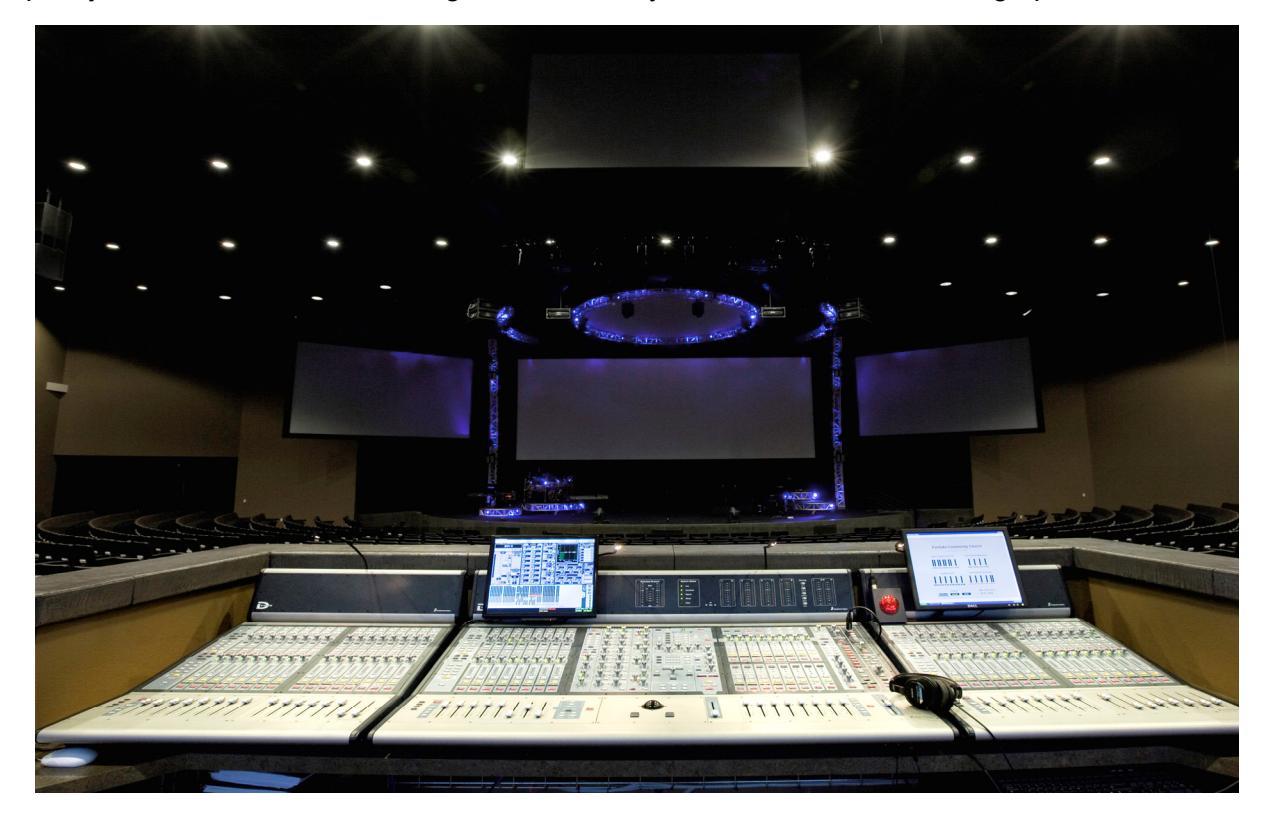
On the previous page there is a view from the FOH mix position, with the D-Show console in the foreground. The two console-mounted video monitors show the D-Show application file on the left and the NetMax DSP metering GUI on the right. In the background, the lighting trusses glow around the center graphics screen.

A Digidesign, Venue Series, D-Show digital mixing console was selected as the optimum choice for FOH duties. It fit all the requirements of the project; price, size, input and output capacity, user friendliness, and elegant connectivity to the Pro Tools recording option.

The D-Show was configured with a main control surface and two side cars, two stage racks, redundant digital snakes and a FOH rack. For the most part, the stage racks were loaded with analog input cards and AES output cards. The FOH rack has additional AES and analog I/O connectivity.

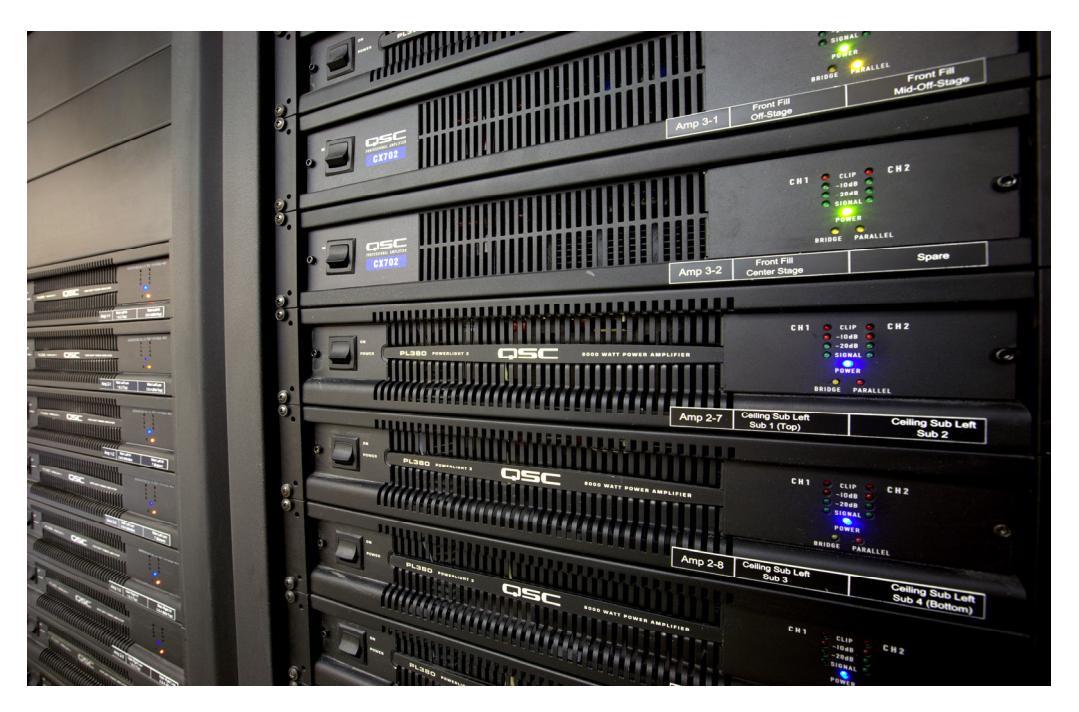
A total of 27, 2-channel, QSC PowerLite 3 and CX amplifiers were used to power the audio system.

QSC PowerLight 3 and CX-series amplifiers are used exclusively. The PL-3s power the Wideline arrays and subs. The CXs power the monitors and all the distributed loudspeakers.

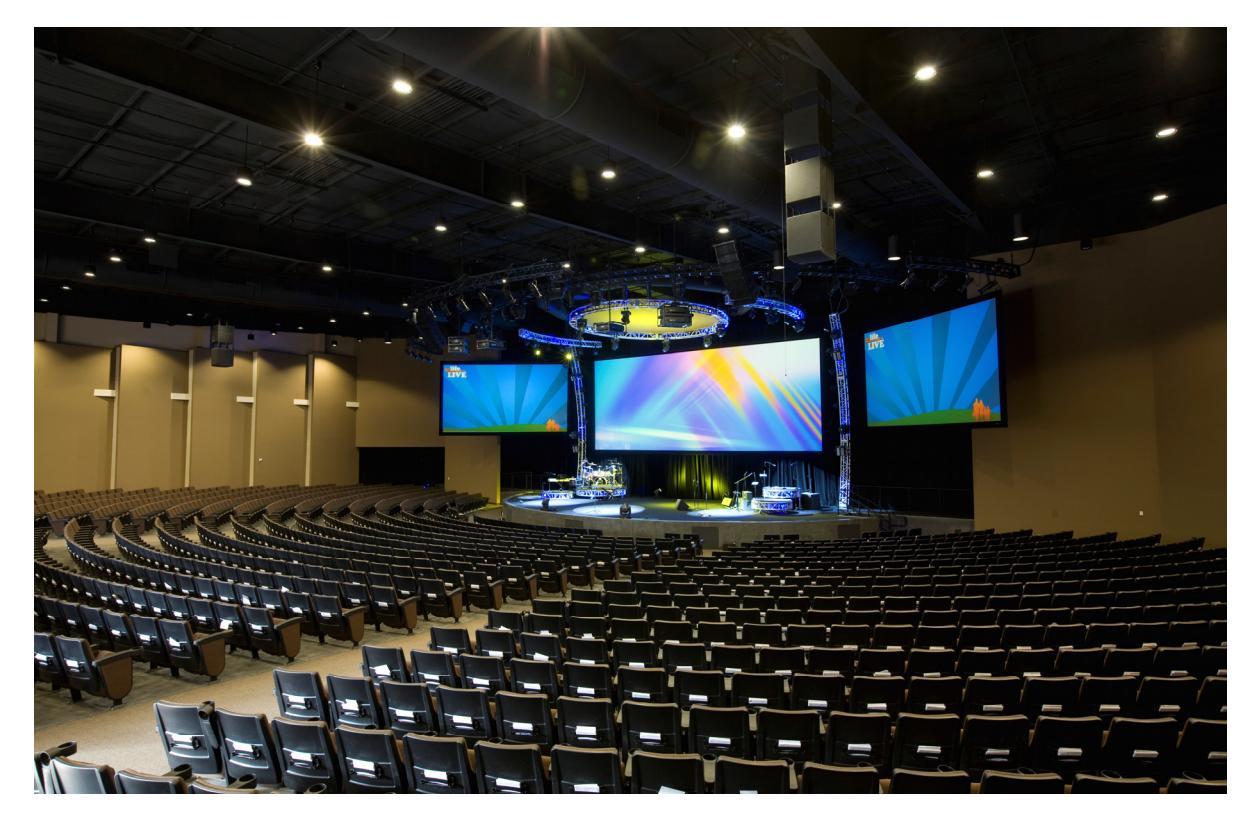
The three main projection screens grab your attention when you first enter the sanctuary. It is approximately 95 feet between the outer edges of the IMag screens on the left and right sides of the stage.

One of the first things you notice when entering the Eastlake sanctuary are the huge video screens. Spread across three screens, there is 1,145 sq. ft. of Stewart Filmscreen material on stage. A 40' x 15' center graphics screen is flanked by two, 22' wide, 16:9 IMag screens.

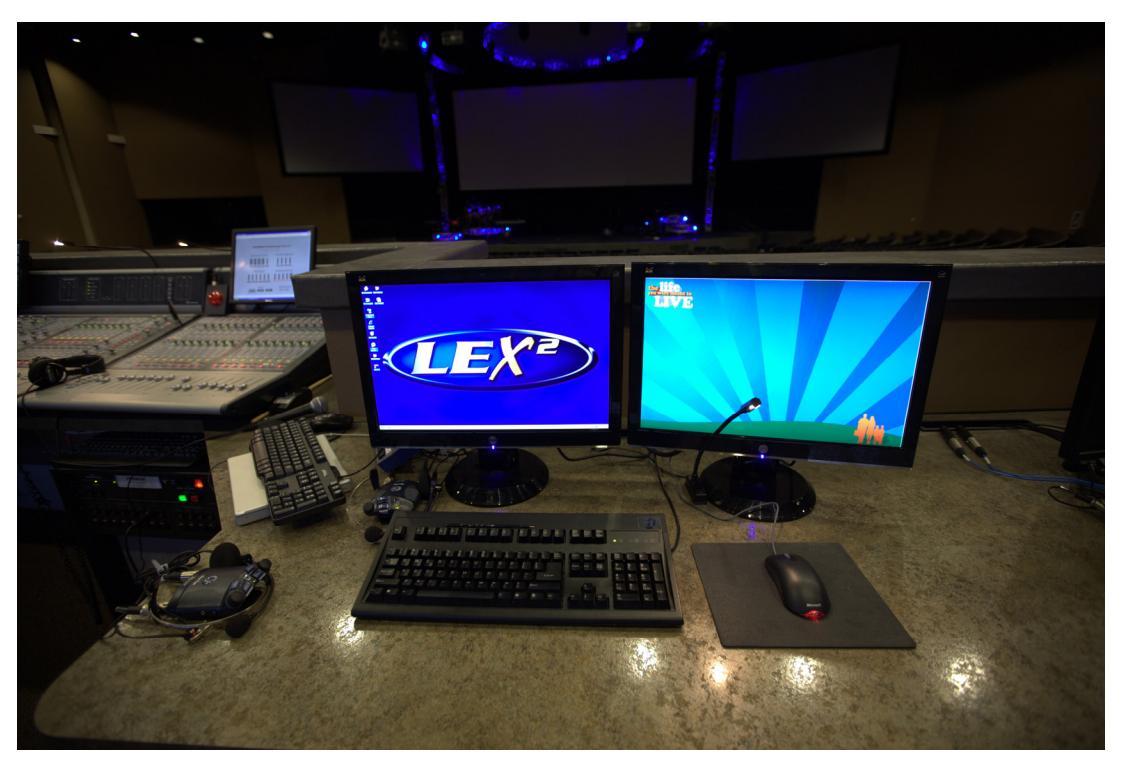
The Chyron workstation is located next to the FOH mix console. The processing engine is mounted in a custom, acoustically-isolated rack that is tucked below the counter.

MJ had a strong desire to work with the highest possible level of graphics insertion hardware and software. After researching a few other products, we settled on his original favorite, the Chyron, LEX 2HD system. The LEX 2 system provides the platform for Eastlake's creative production team to create custom lower-third graphics, logos, full-screen lyric overlays, and an alpha-channel buss to insert a live camera feed from the upstream, Panasonic HD camera switcher.

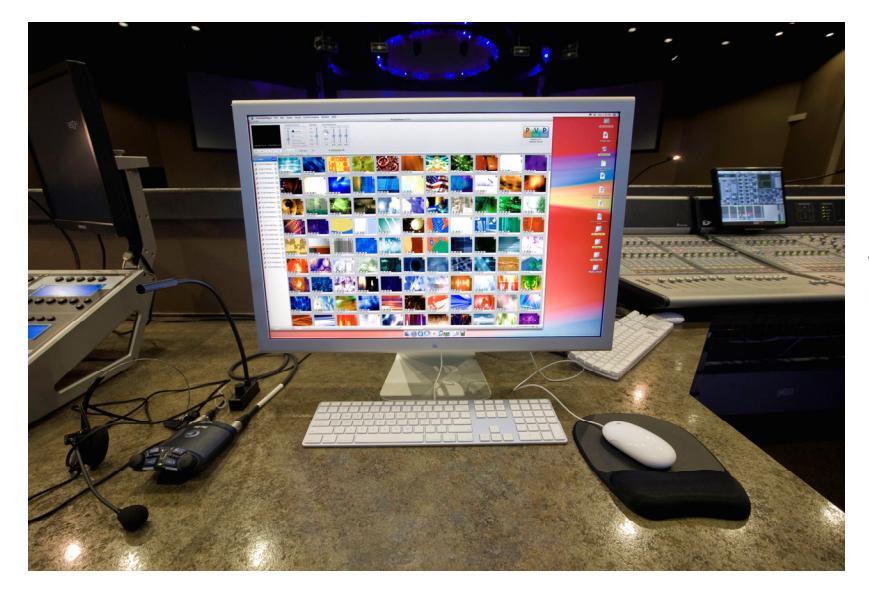
The Pro Video Player workstation is located on the left side of the FOH mix console. A Mac Pro computer is mounted under the counter

The source material for the center screen is created and managed on an Apple Mac Pro computer running Renewed Vision's Pro Video Player software. To help manage the budget, we determined that a 5-component, analog signal path would be sufficient for the center screen graphics.

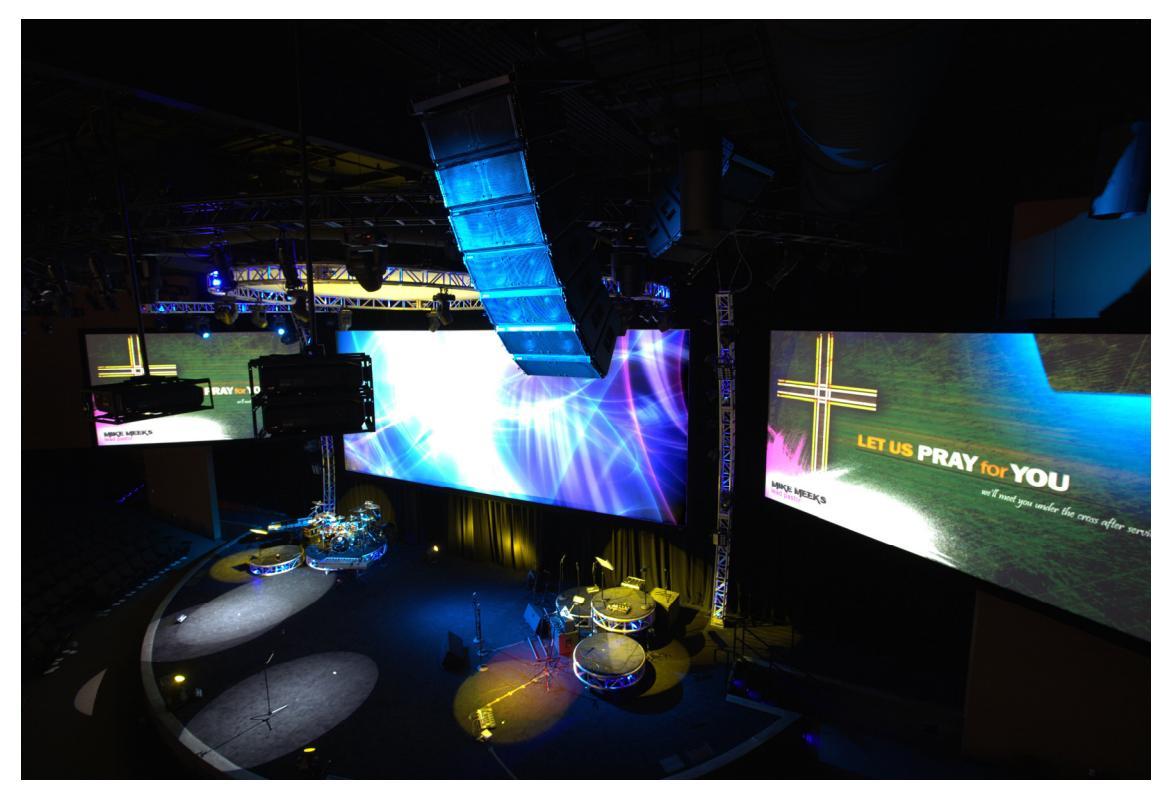
Another overhead view of the stage with the Widelines highlighted in the foreground, and the center graphics and IMag screens in the background.

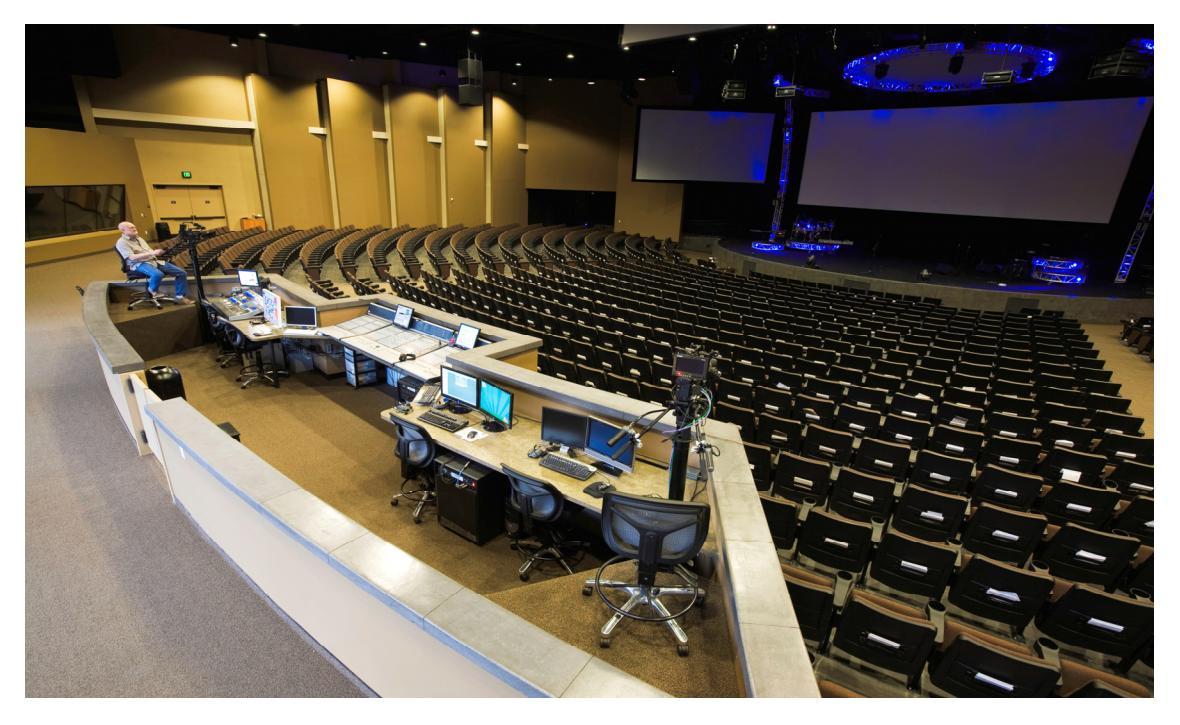
The unique, center-forward design of the FOH tech booth improves the lateral sightines for the technical crew while adding geometry and character to the room.

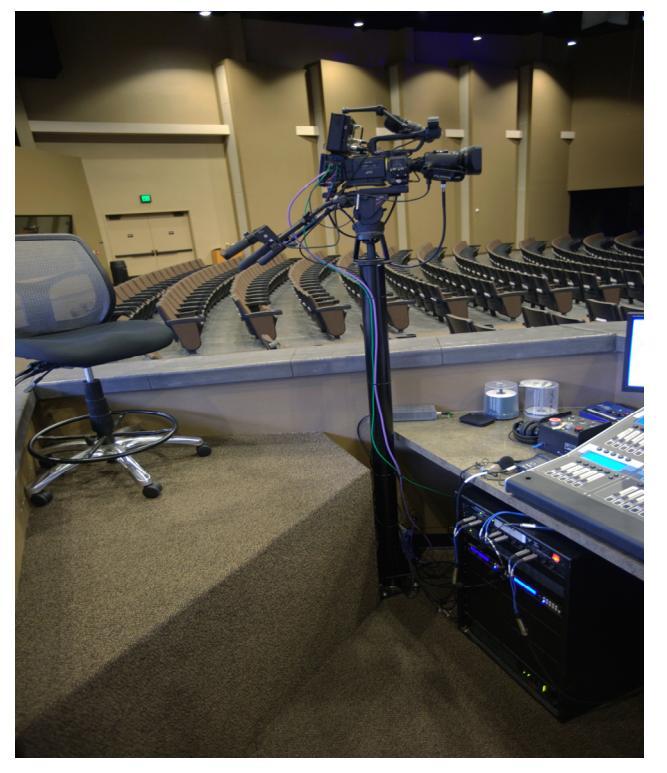
The house-left camera position in the FOH tech booth.

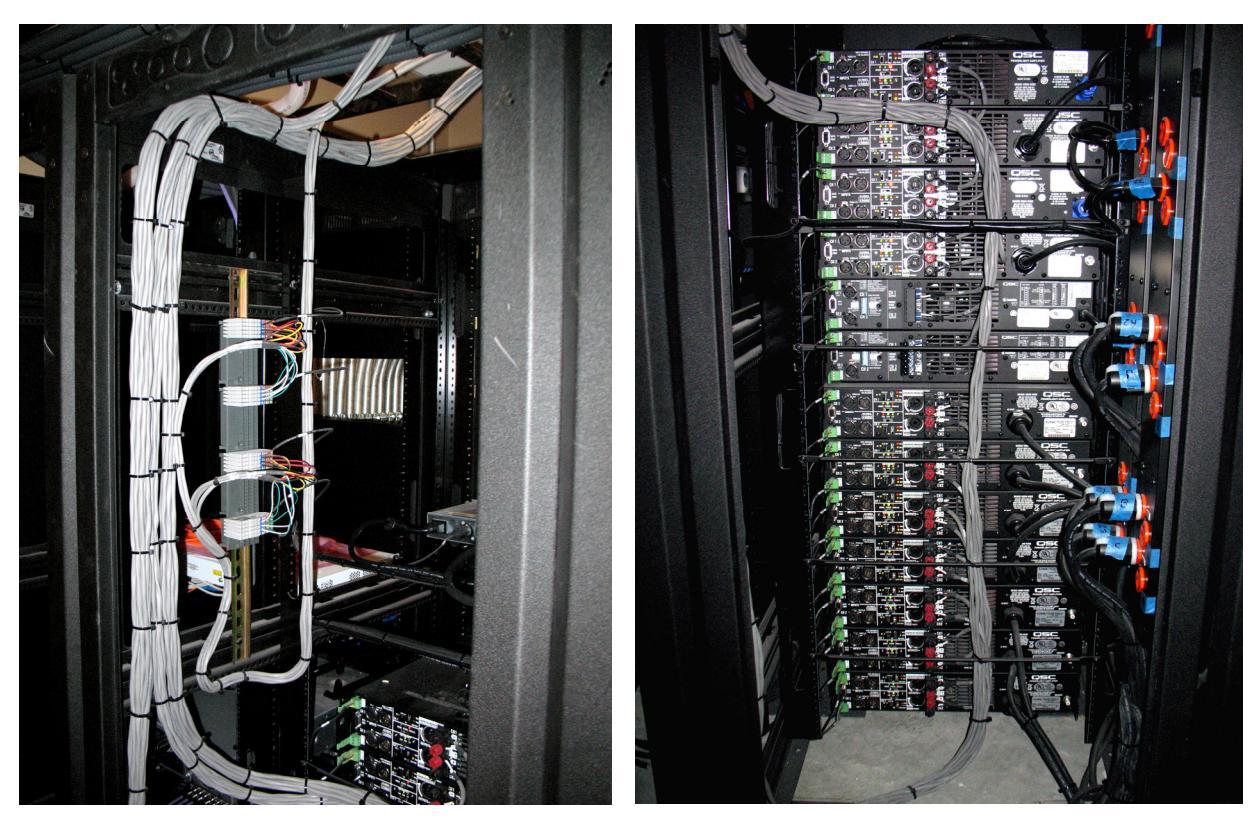
The highly-organized cable infrastructure compliments the overall quality of the installation.
